PUBLIC RIGHT-OF-WAY ACCESSIBILITY TRANSITION PLAN

August 2021

Prepared by
Christopher B. Burke Engineering, Ltd.
9575 W. Higgins Road, Suite 600
Rosemont, IL 60018

PUBLIC RIGHT-OF-WAY ACCESSIBILITY TRANSITION PLAN
EXHIBIT A - SECONDARY EVALUATION RESULTS

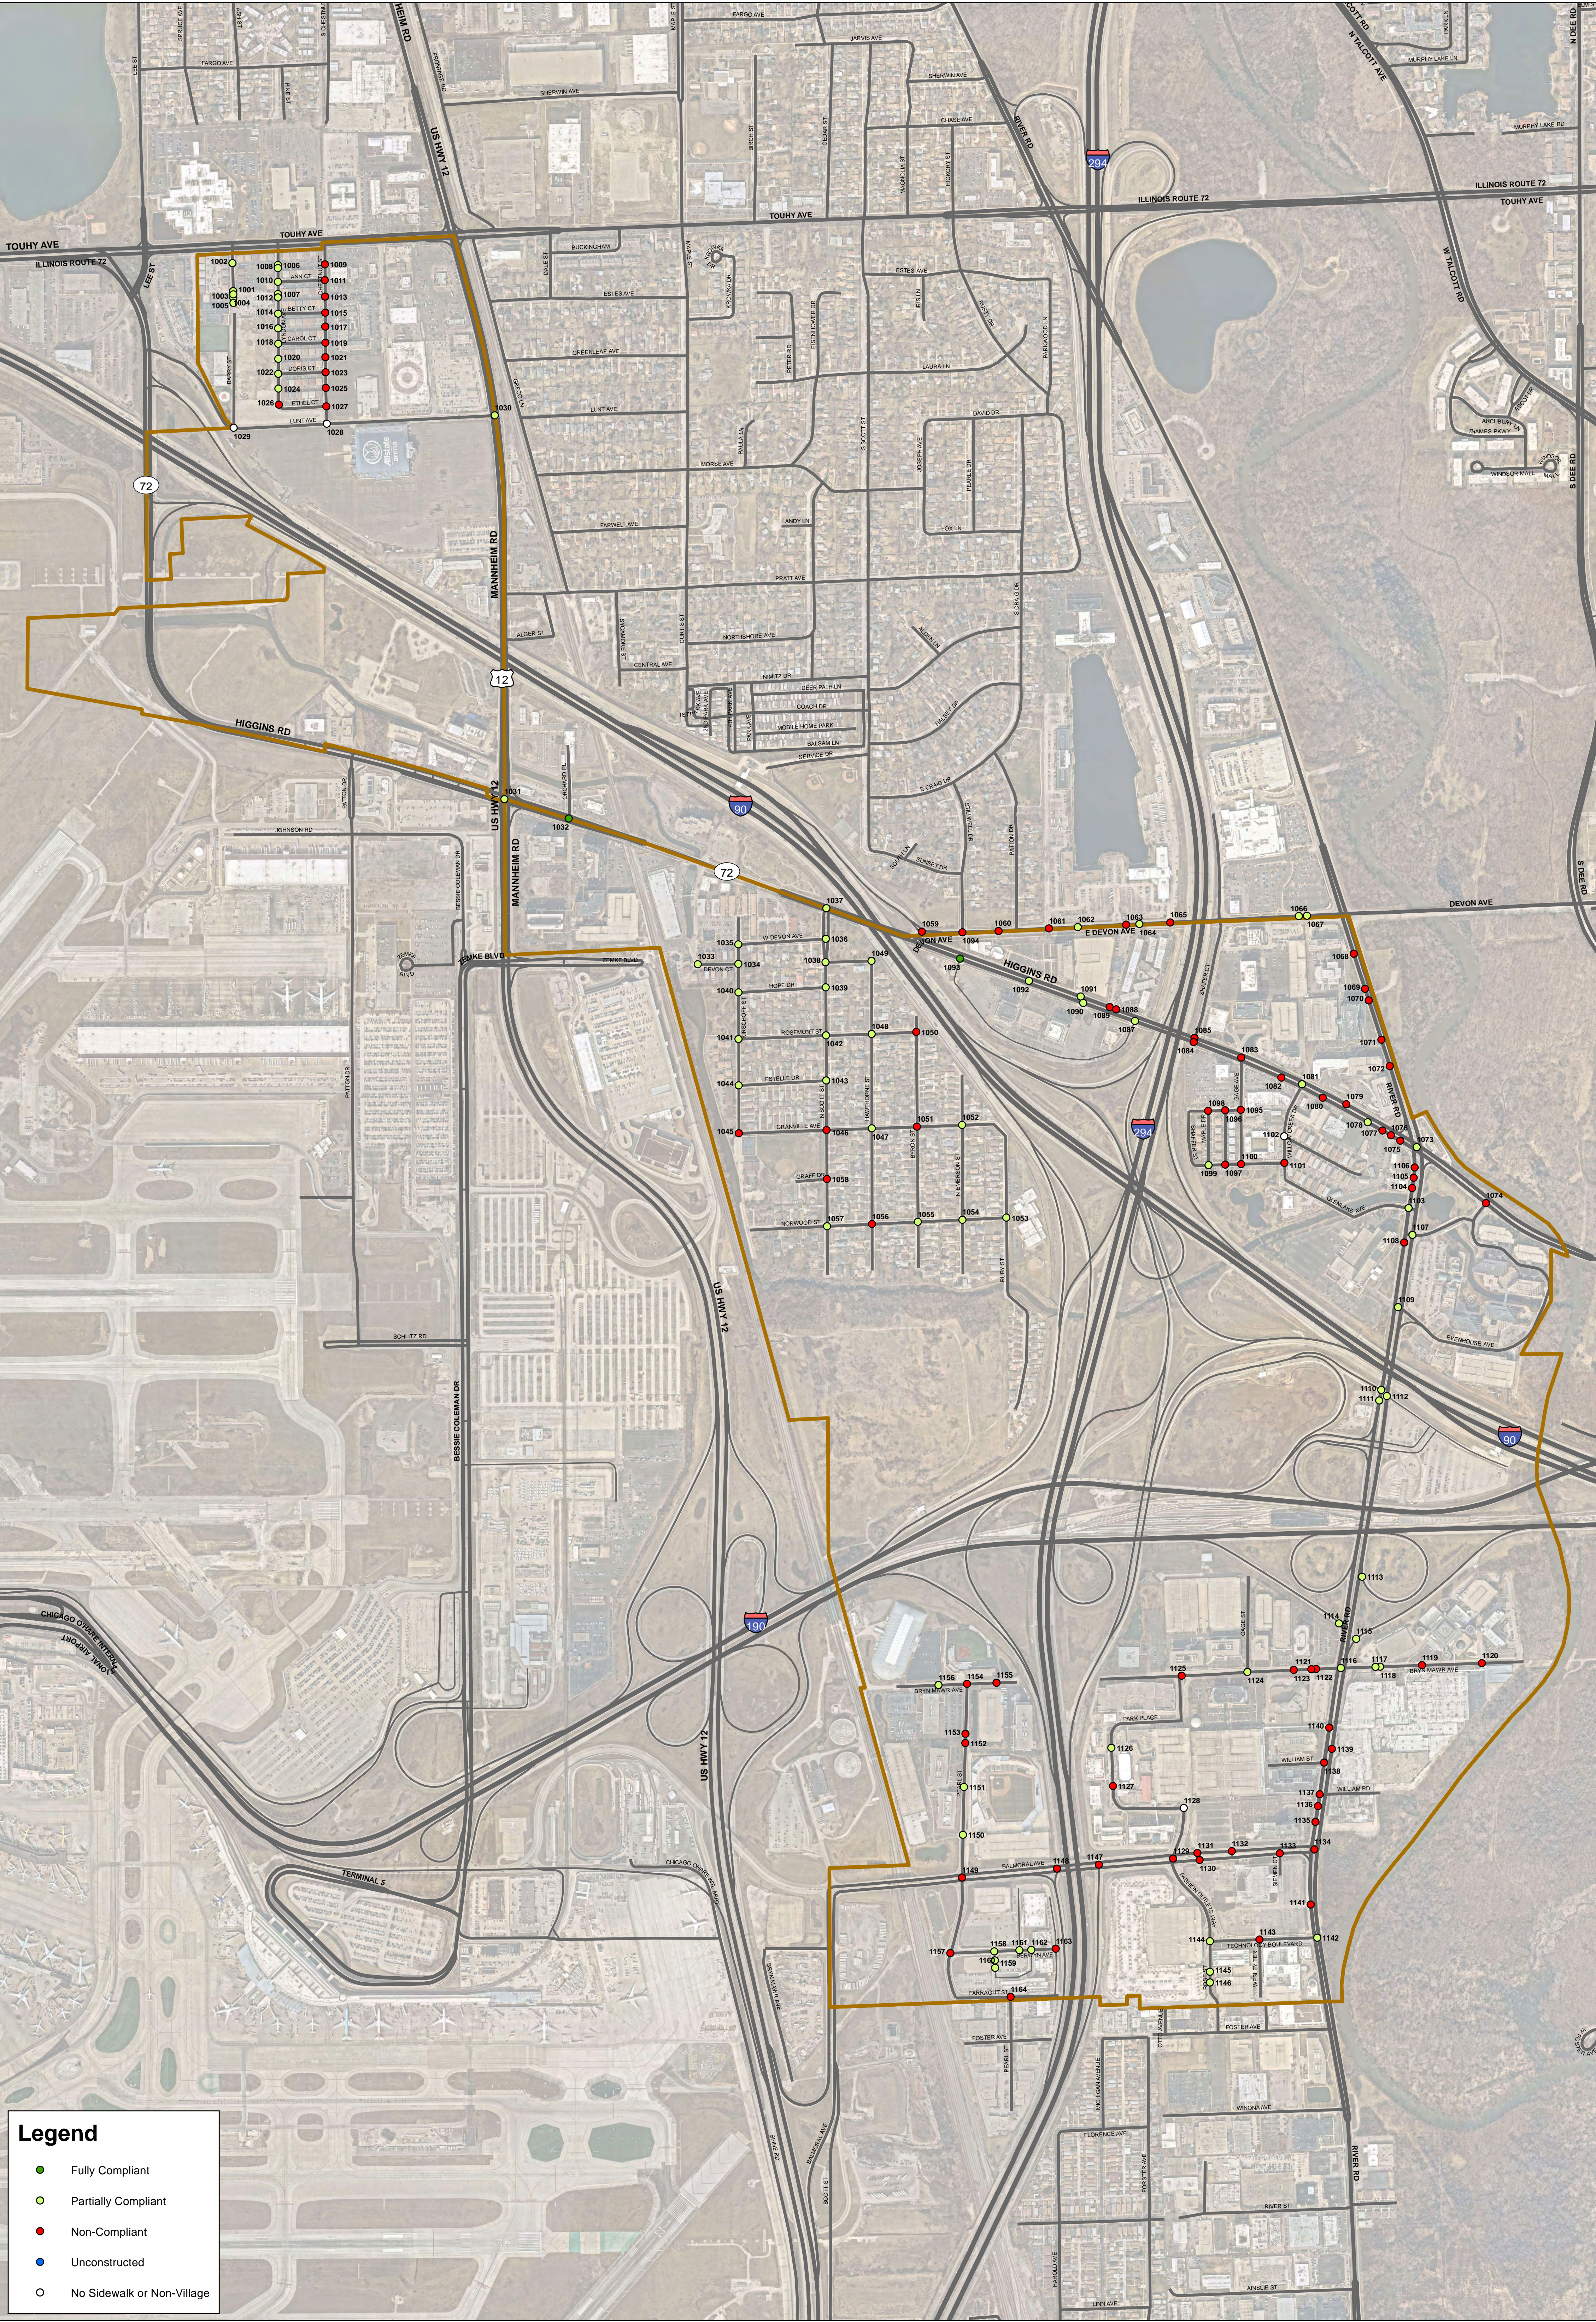
The Secondary Evaluation provided the following results:

- 164 intersections analyzed
- 160 total intersections with curb ramps evaluated
- 2 intersections (1%) identified as “Fully Compliant”
- 76 intersections (48%) identified as “Partially Compliant”
- 82 intersections (51%) identified as “Non-Compliant”

Exhibit A illustrates the findings of the Secondary Evaluation. In addition to those intersections noted above, 4 intersections were identified as “N/A”.
